TECHNICAL REPORT ARCCB-TR-91034

**MATERIALS ANALYSIS OF A
FATIGUE TESTING MANDREL**

**M. BRODSKY
J. SENICK
G. YOUNG**

NOVEMBER 1991

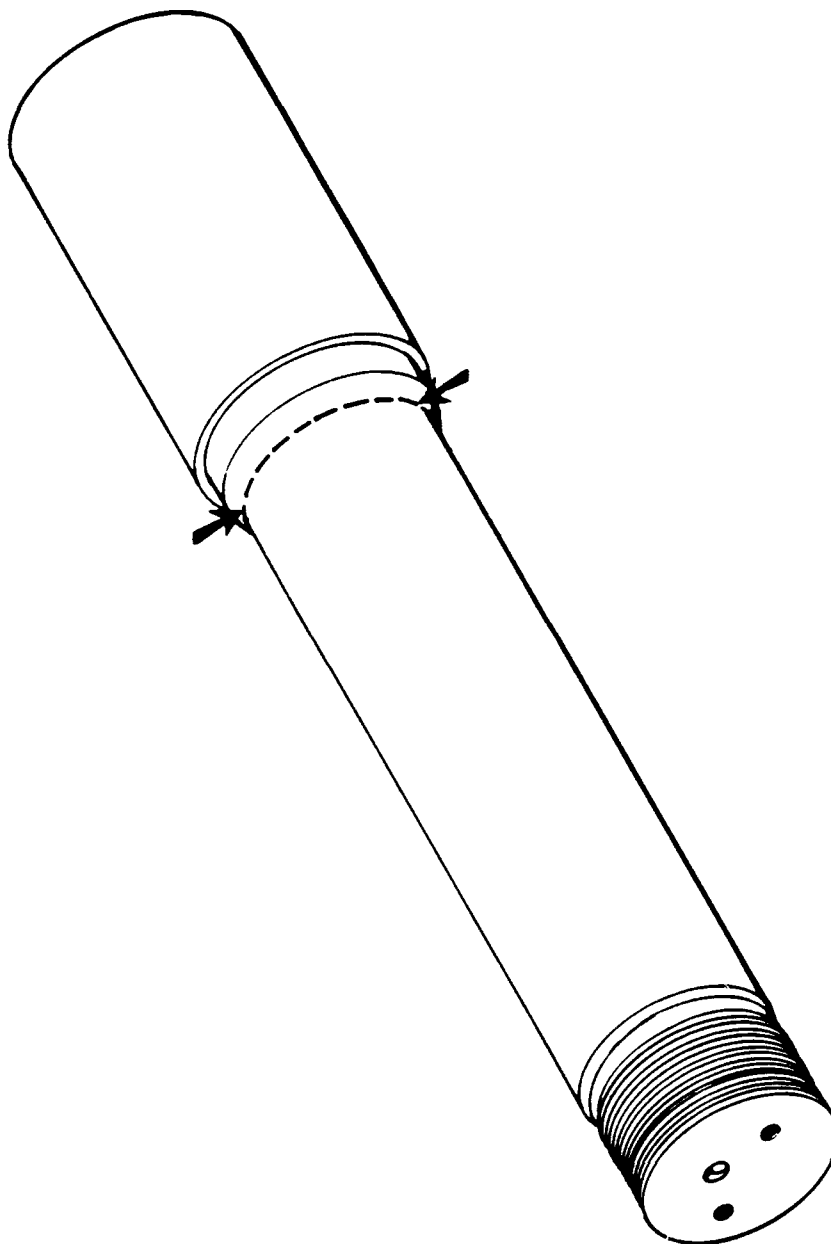
The mandrel fractured at the sharpest radius point as shown in Figure 5. When a post-failure inspection was performed on this area, the radius was measured and the average was determined to be 0.030 inch. This measurement,

although within specifications of $0.03R + 0.01$, was at the low end of the requirement, making this radius the sharpest acceptable within the above limits.

Figure 5. Schematic of fatigue testing mandrel showing location of failure.

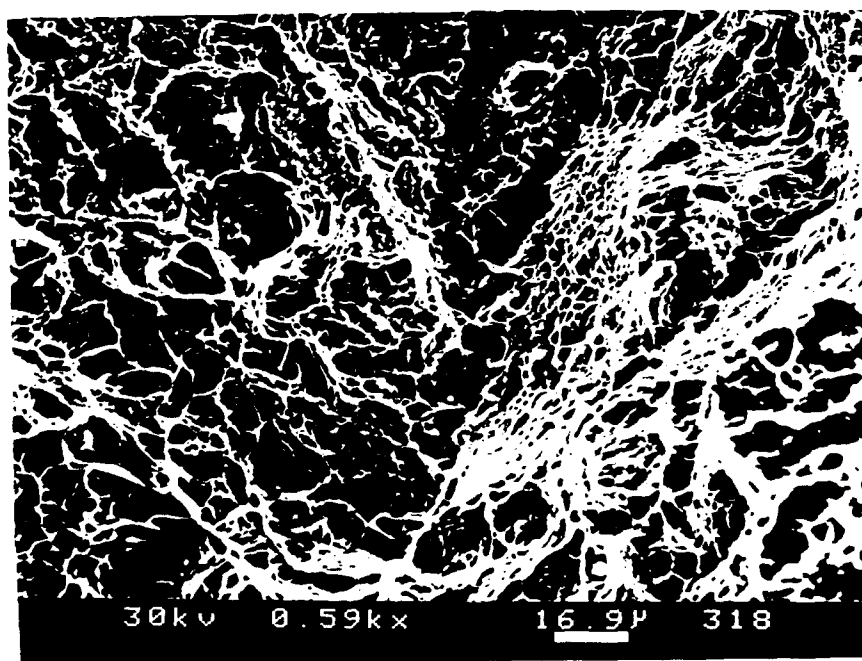
Figures 7a through 7c. In contrast, the center region of the fracture surface displayed rather ductile characteristics, as shown in Figure 7d.

Figure 7d. Ductile rupture discovered in center region of fracture surface. Secondary emission (590X).

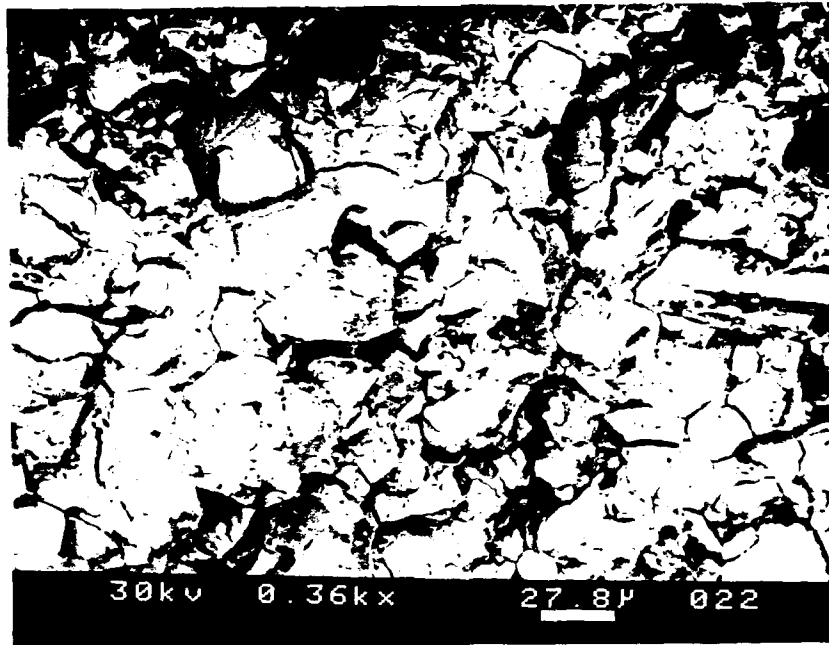
Figure 9a. Fractograph of secondary crack showing intergranular cracking. Backscatter emission (360X).

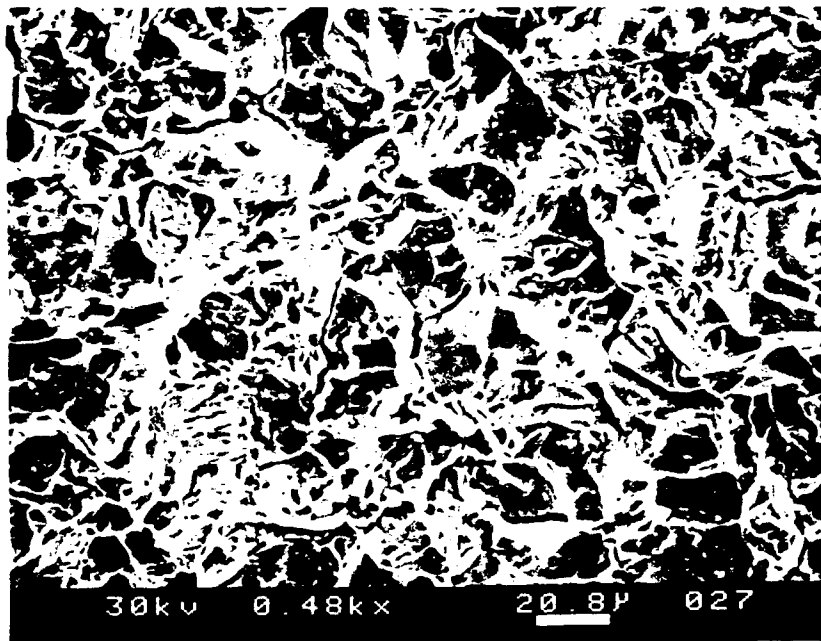
Figure 9b. Fractograph of secondary crack showing intergranular cracking. Secondary emission (480X).

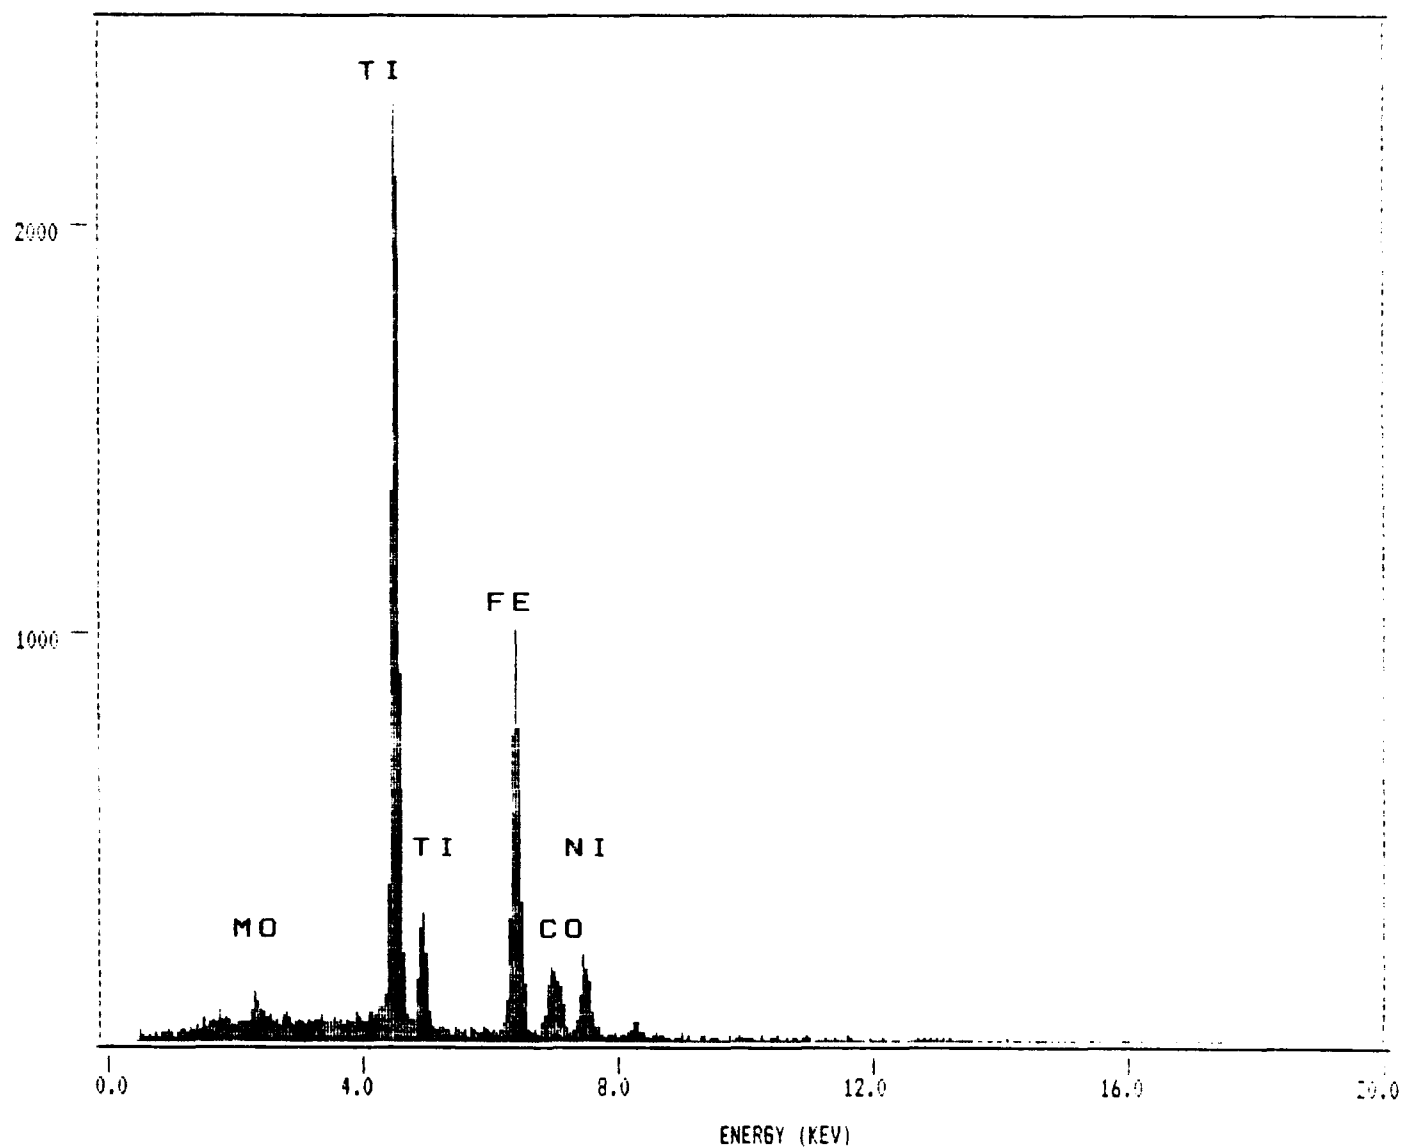
Energy dispersive spectroscopy (EDS) was conducted on the metallographic samples, and the two particle types that were analyzed are displayed in Figure 10. The results in Figure 11 show that the bright, globular-shaped particles are titanium-rich, common to maraging steels, while the elongated particles are additionally rich in molybdenum as illustrated in Figure 12.

Figure 11. EDS analysis of globular particle.

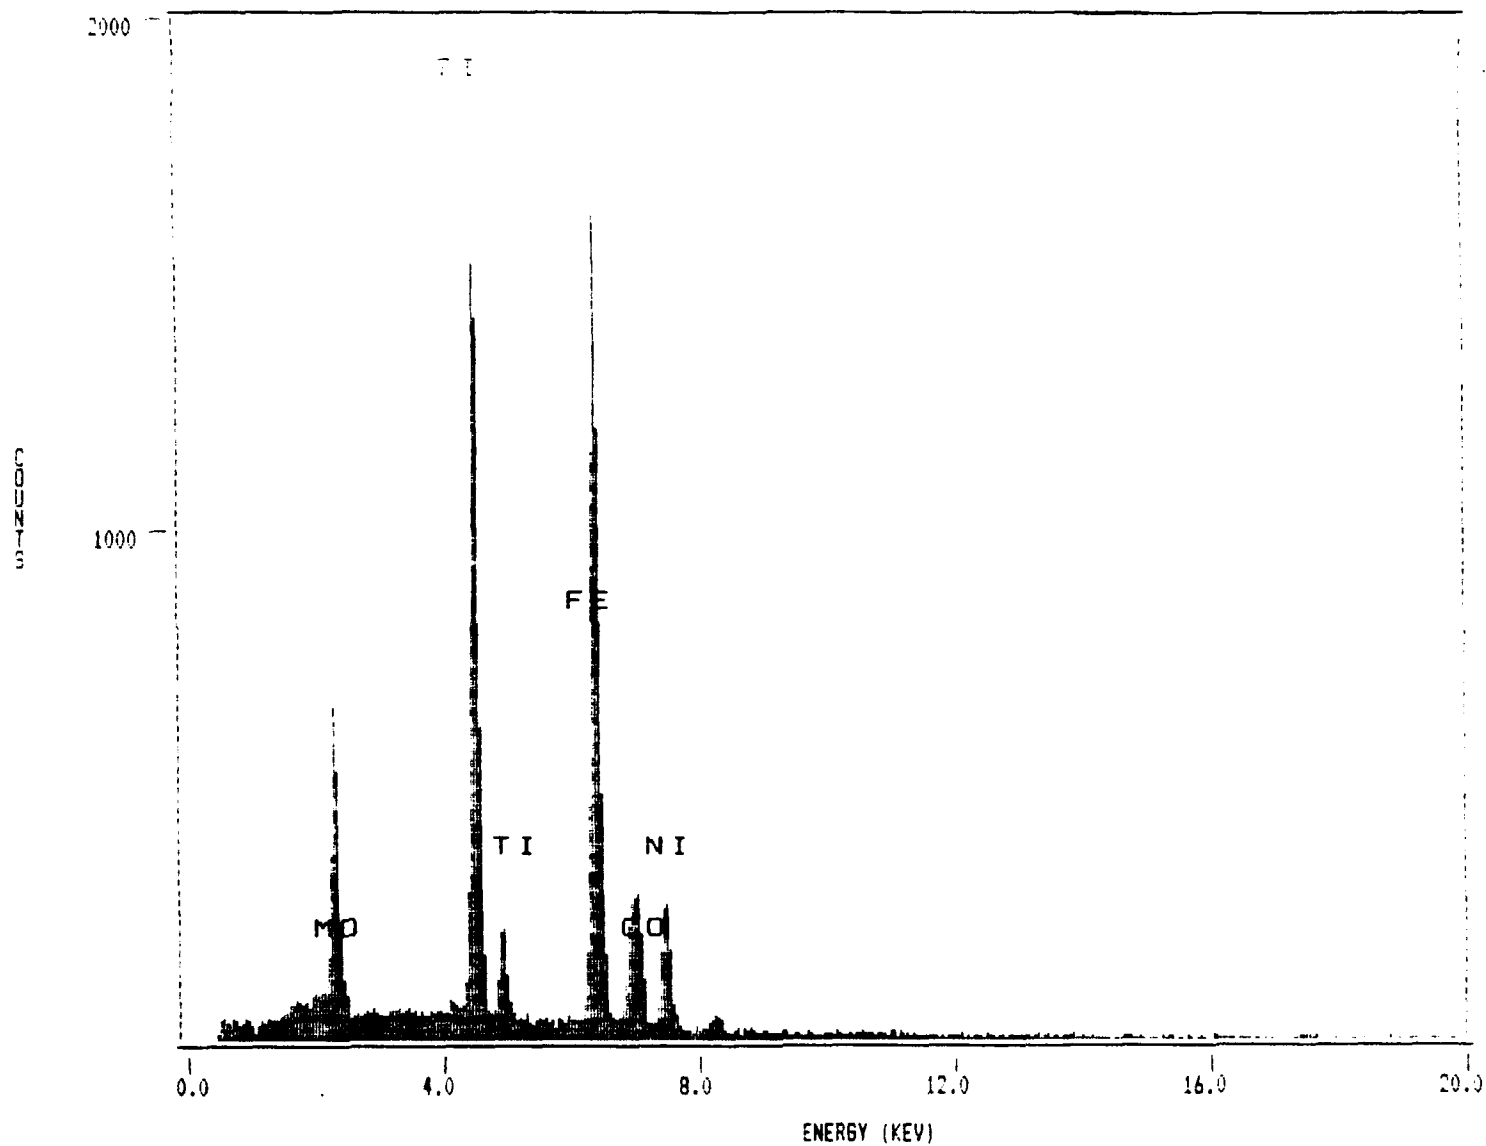
Figure 12. EDS analysis of elongated particle.
